First Annual Monitoring Report

Oak Woodland Habitat Revegetation/Mitigation Program for the Santa Anita Dam Riser Modification and Reservoir Sediment Removal Project

**California Department of Fish and Wildlife
Streambed Alteration Agreement
No. 1600-2008-0173-R5**

October 2016
Revised February 2017

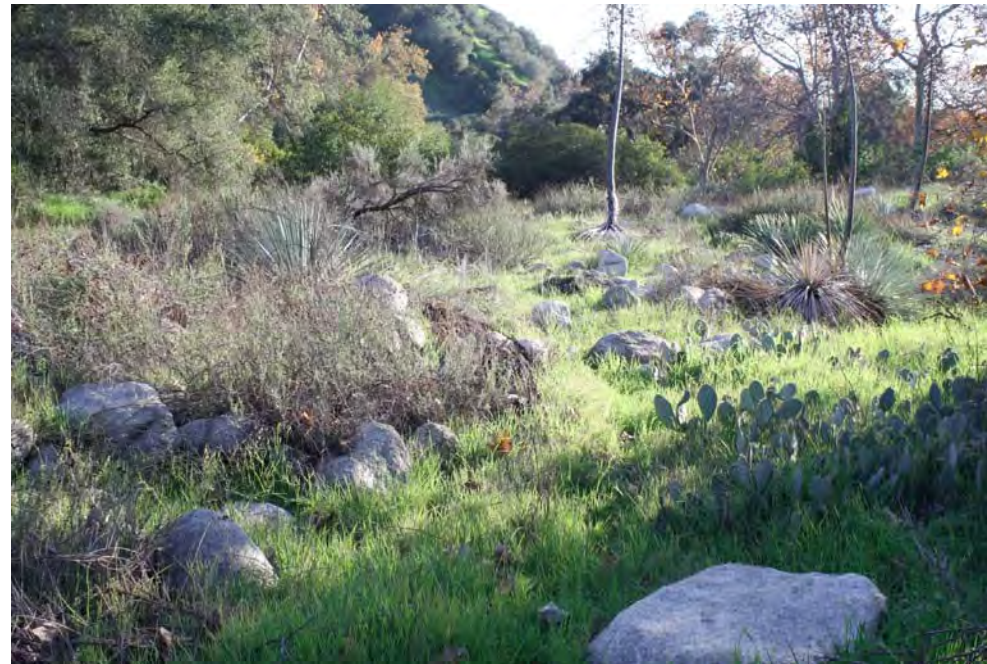
January 2011. The coastal sage scrub reference site (Middle SPS) exhibits patches of native scrub and a dense understory of weedy grasses and herbs.

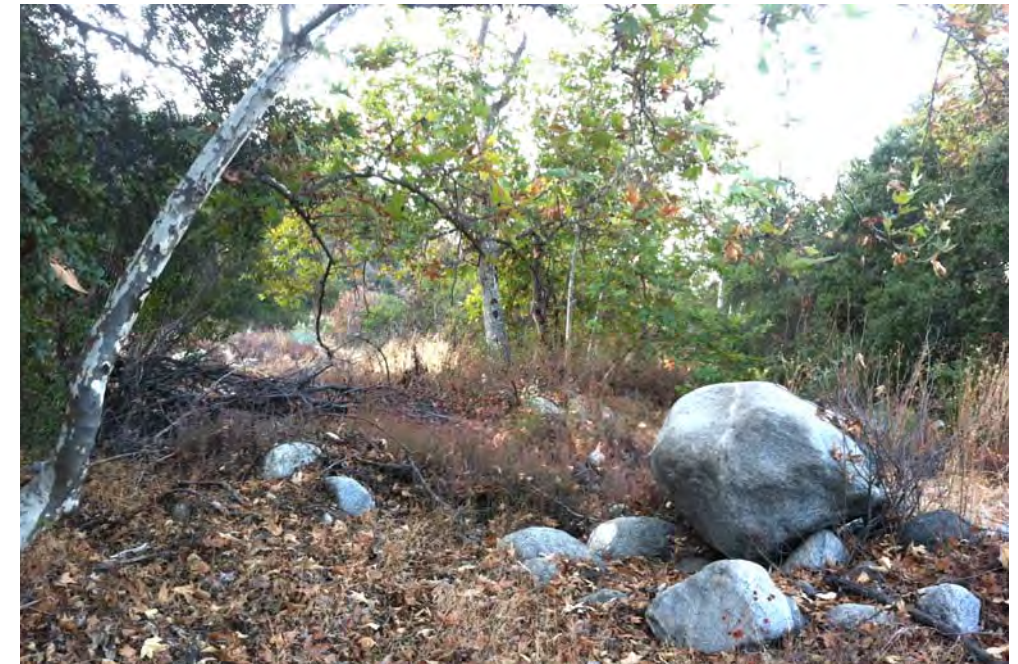
October 2012. The Middle SPS reference site contains some natural boulders and coarse woody debris, which are beneficial habitat features that are being re-created on the Lower SPS mitigation site.

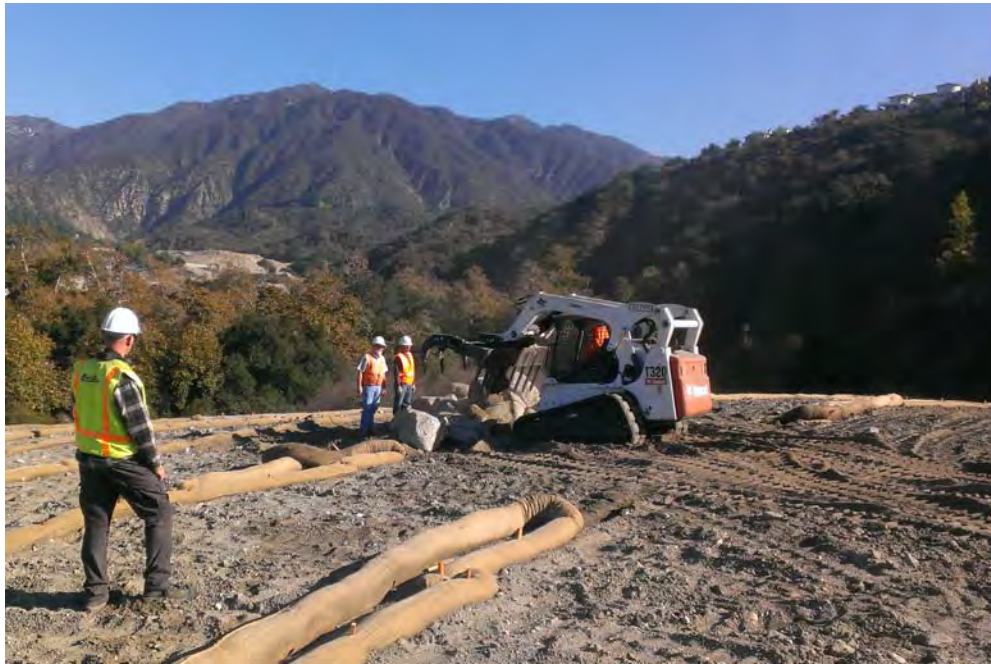
September 2013. Photo Station No. 1. The northern portion of the Lower Sediment Placement Site (SPS)(coastal sage scrub mitigation site) during mitigation site installation tasks.

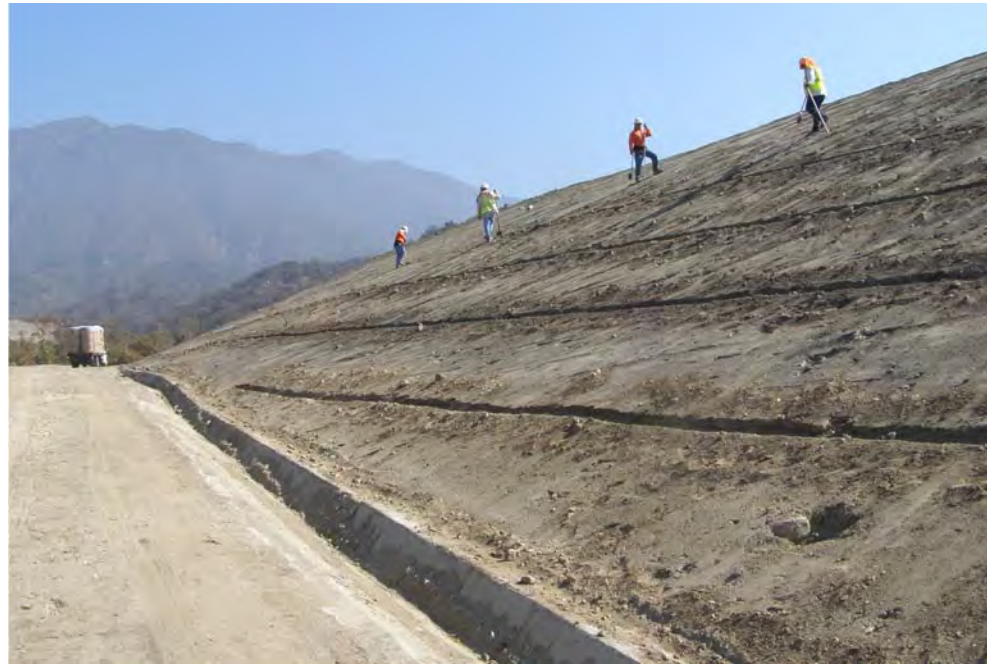
September 2013. Photo Station No. 2. The western slope of the Lower SPS (coastal sage scrub mitigation site) during mitigation site installation tasks.

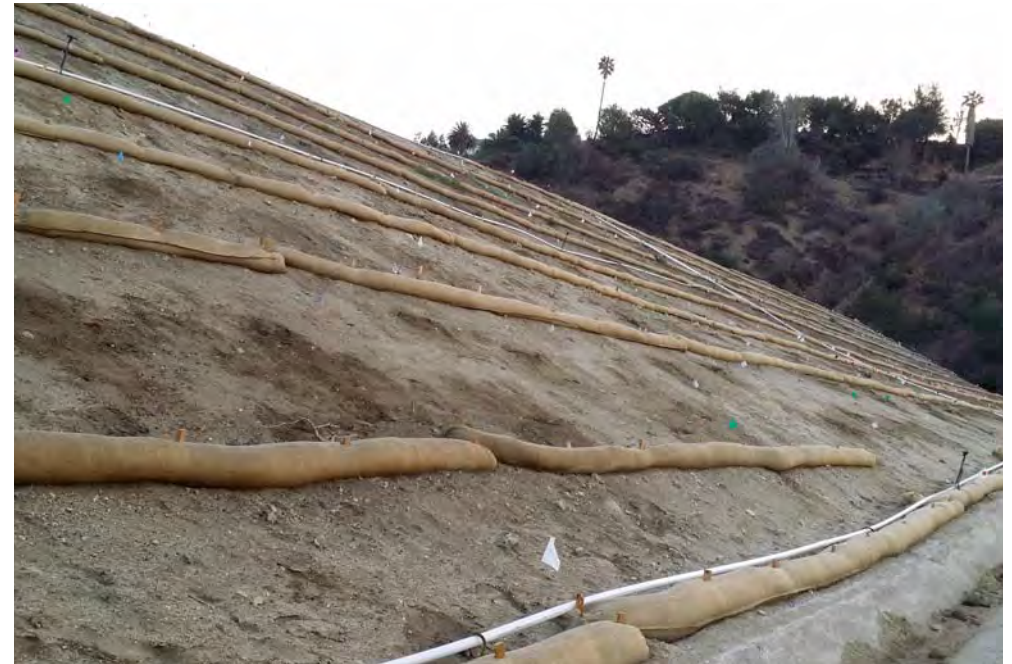
September 2013. Photo Station No. 3. The southern slope of the Lower SPS (coastal sage scrub mitigation site) during mitigation site installation tasks.

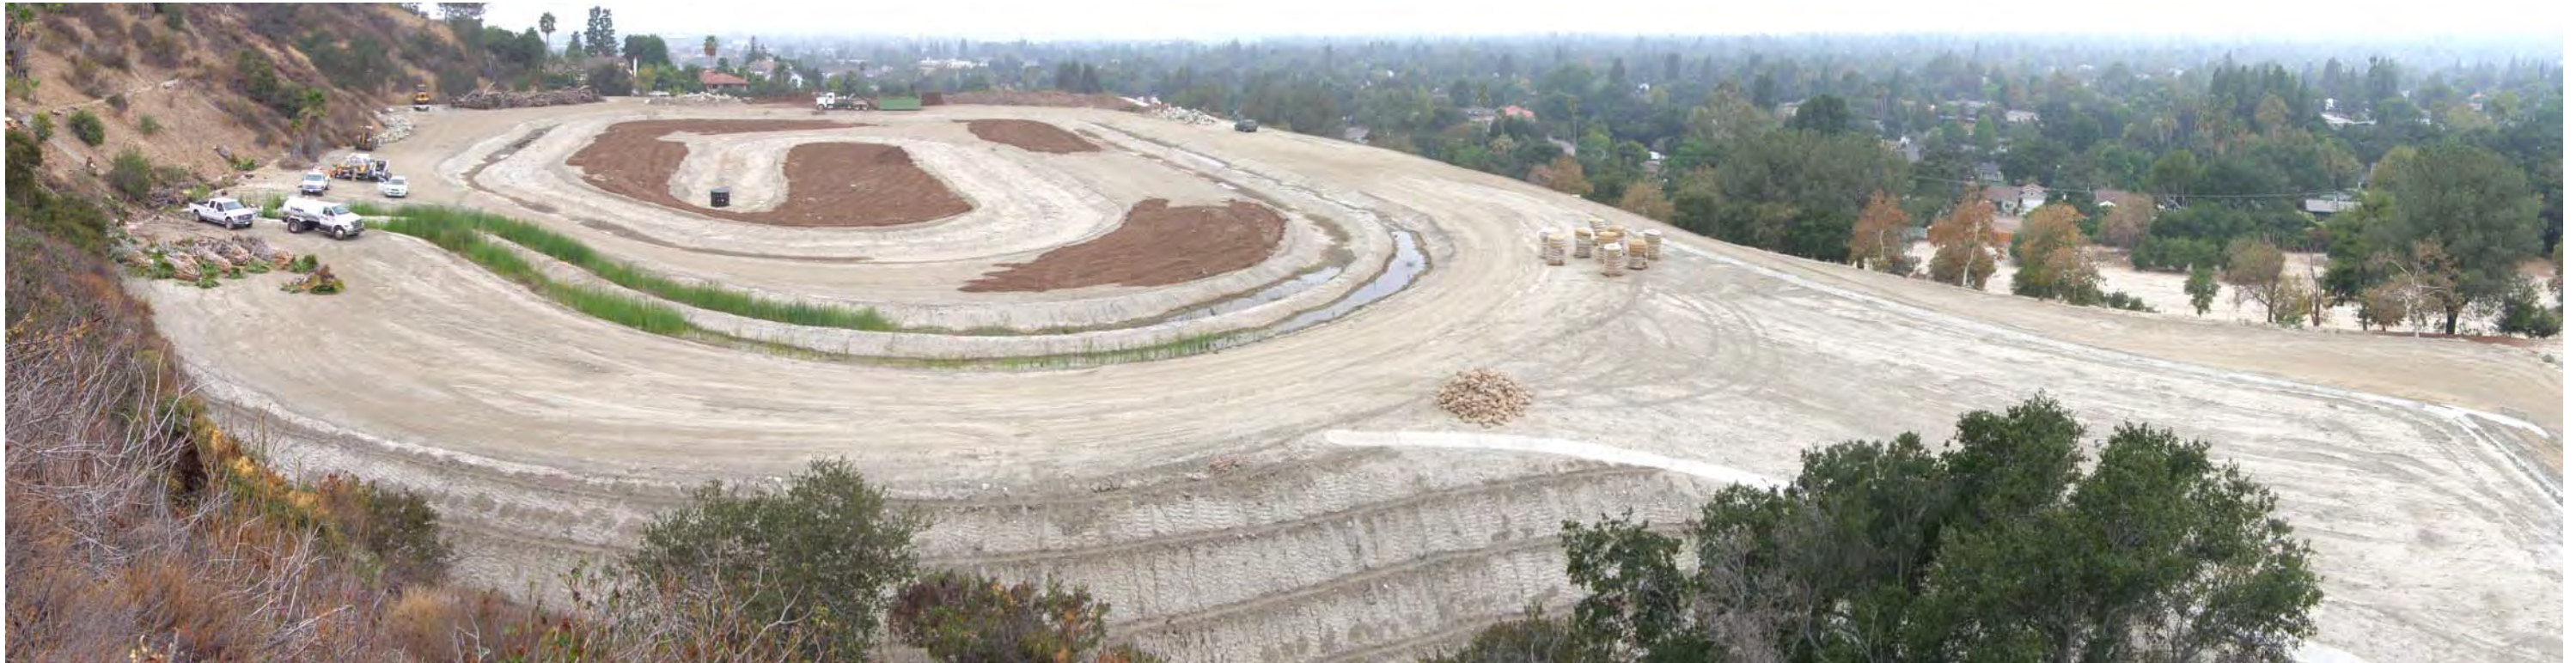
September 2013. Photo Station No. 4. The deck of the Lower Sediment Placement Site (oak woodland mitigation site) during the placement of salvaged mulch.

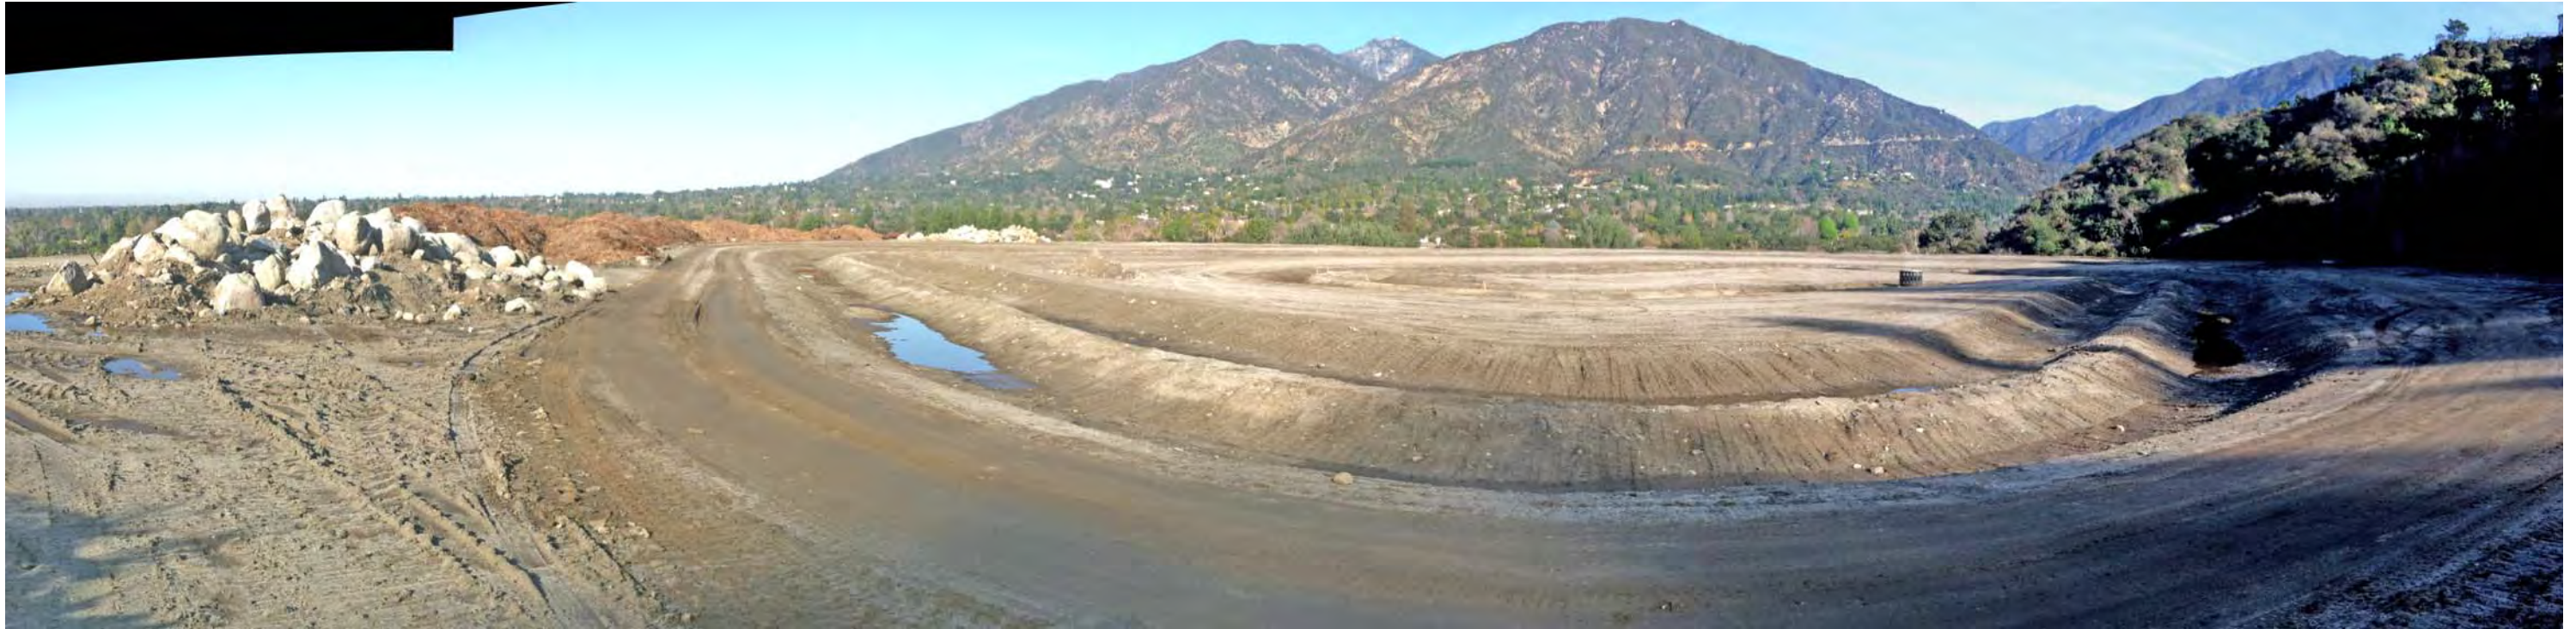
January 2013. Photo Station No. 5. The deck of the Lower Sediment Placement Site (oak woodland mitigation site) prior to project implementation. A temporary stockpile of salvaged boulders is visible to the left.
